**CWA COMPLIANCE EVALUATION INSPECTION REPORT  
U.S. ENVIRONMENTAL PROTECTION AGENCY, REGION 5**

Compliance Evaluation Sampling Inspection

Sandway Farm, LLC  
E1411 Bolt Road  
Denmark, WI 54208  
44.341N, 87.699W

April 18, 2013

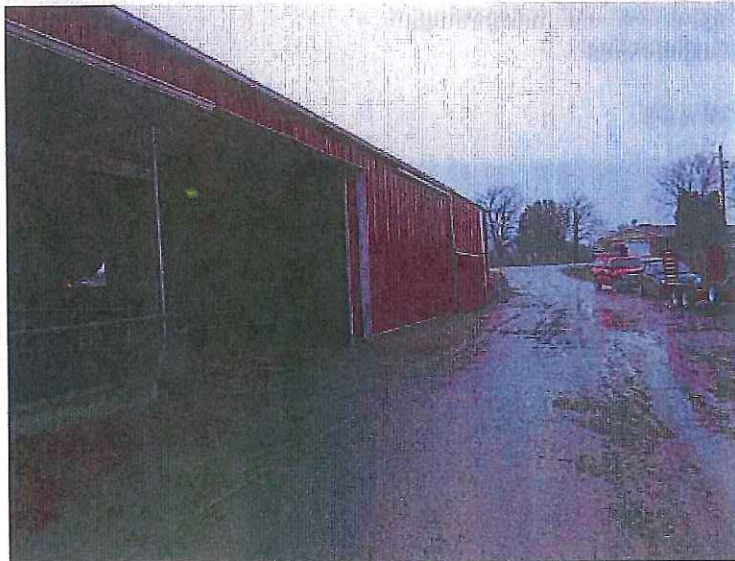
There are 12 close-up dry cows inside the Machine Shed. Feed for these cows is placed on the ground outside the barn in a feed lane. Although there is an overhang with a gutter on the roof of the building, some feed could flow with the precipitation to the south. There was a small amount of track in/track of raw materials from door of the Machine Shed.

IMGP0004: Machine Shed on west side of facility also houses a dozen close-up dry cows.

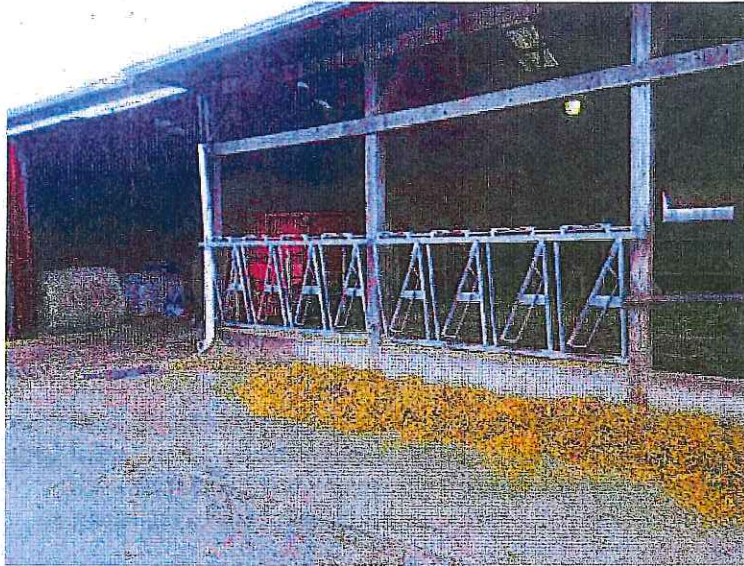
**IMGP0006:** A roof overhang and eave gutters on Machine Shed help keep the precipitation from landing on feed and transporting it.

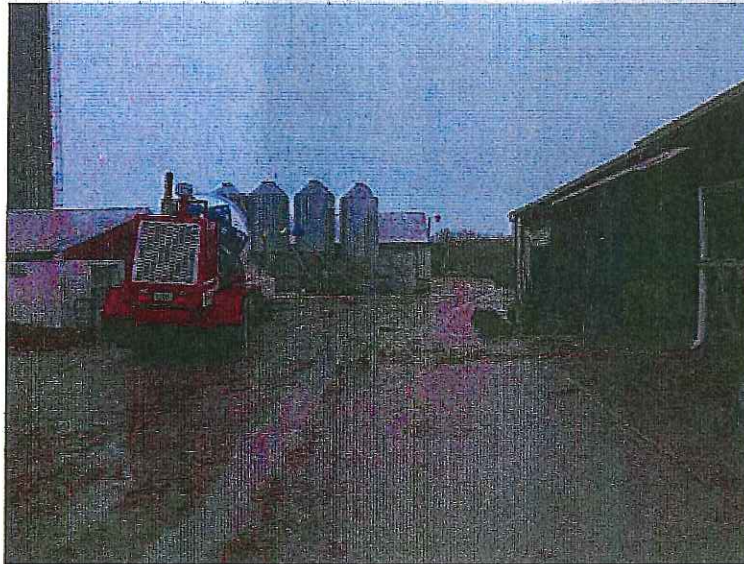
**IMGP0007:** Small amount of track in/track out in front of Machine Shed.

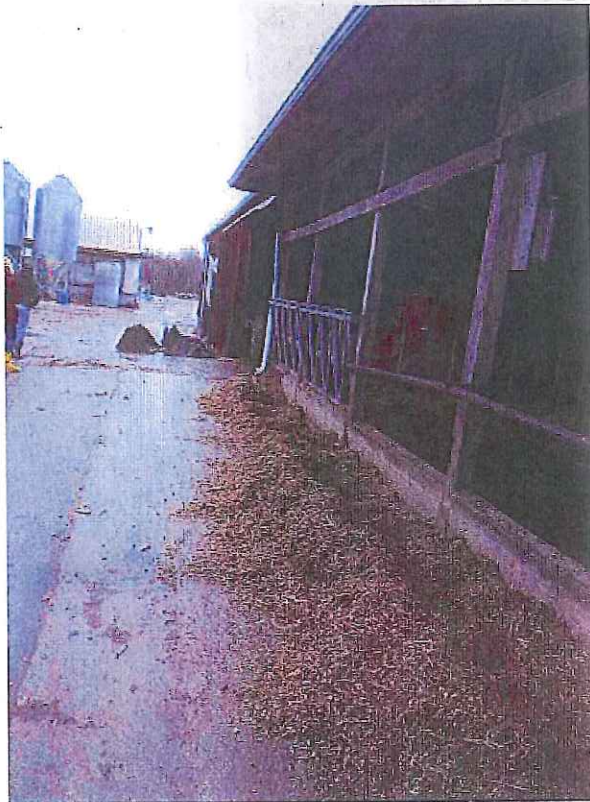
IMGP0008: Feed for close-up dry cows is open to the elements.

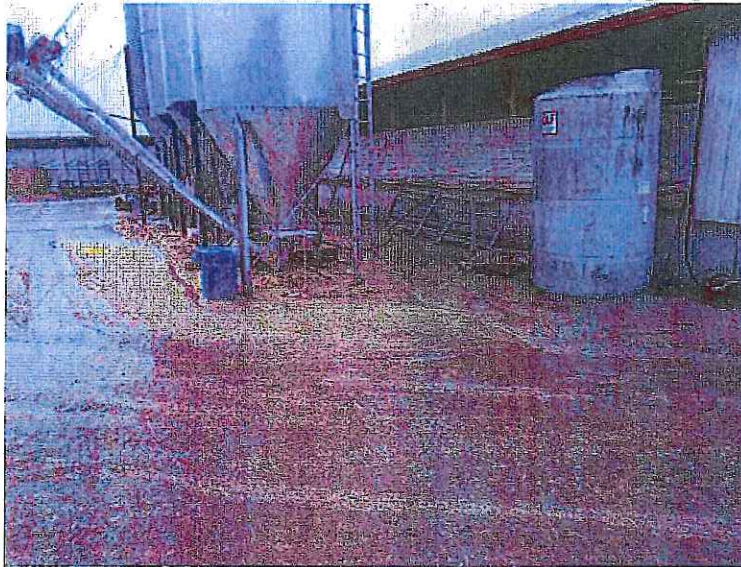
IMGP0013: Feed below the bulk bins can be transported with storm water to the south.  
 Location: Bulk bins on north side of Dry Cow Barn  
 Facing: East  
 Date/Time: 4/18/13 10:14 A.M.

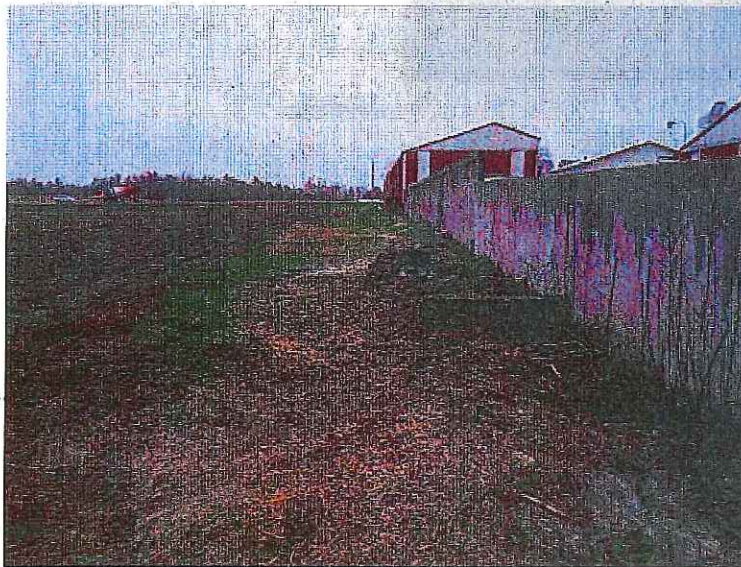
Additional feed storage bunkers were located south of the Dry Cow Barn. Snow, with spilled feed incorporated in it, had been pushed to the edge of the silage pad and into the West Ditch. There was no constructed berm on the west side of the silage pad to prevent raw materials and process wastewater from being flushed to the West Ditch during precipitation events. EPA observed channelization of flow off the silage pad to the West Ditch and noted that there was water in the West Ditch on the day of the inspection.

IMGP0017: Silage spilled on the ground west of the Silage Bunker can be transported to the West Ditch. There is snow piled under the silage.  
 Location: Southwest of Silage Bunker  
 Facing: North  
 Date/Time: 4/18/13 10:18 A.M.

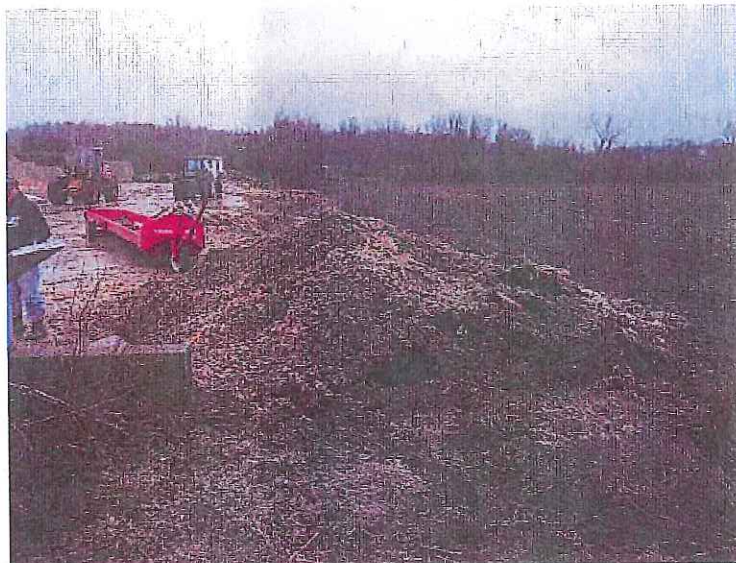
IMGP0018: Snow and silage from silage pad are pushed off the silage pad into the West Ditch.

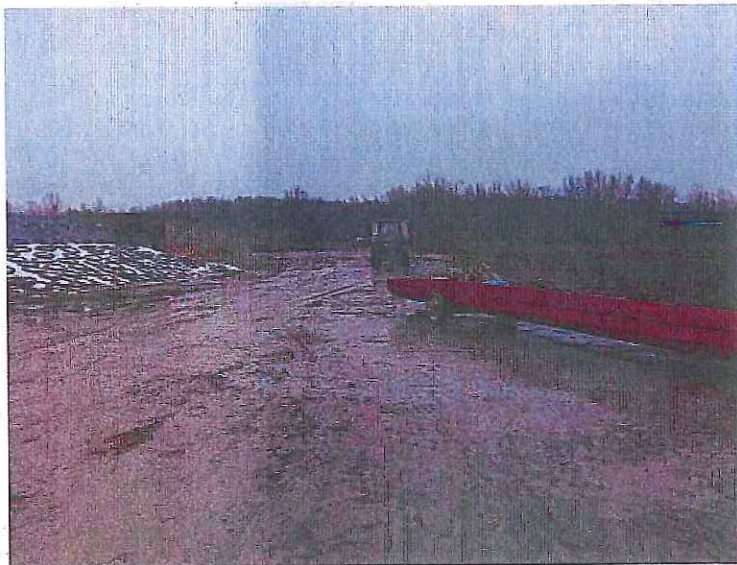
IMGP0022: Silage pad has no berm on the west side to prevent leachate from flowing into the West Ditch.

EPA noticed that the silage pad was tilted to the west so that flow of precipitation would flow off the pad to the west. There was nothing in place to prevent the raw materials and leachate from flowing with the precipitation to the west and to the West Ditch or to the south and to Pasture #1.

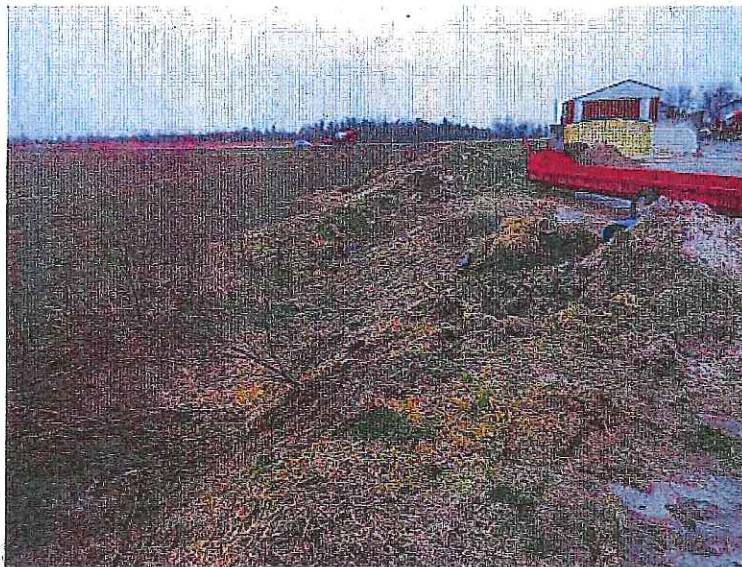
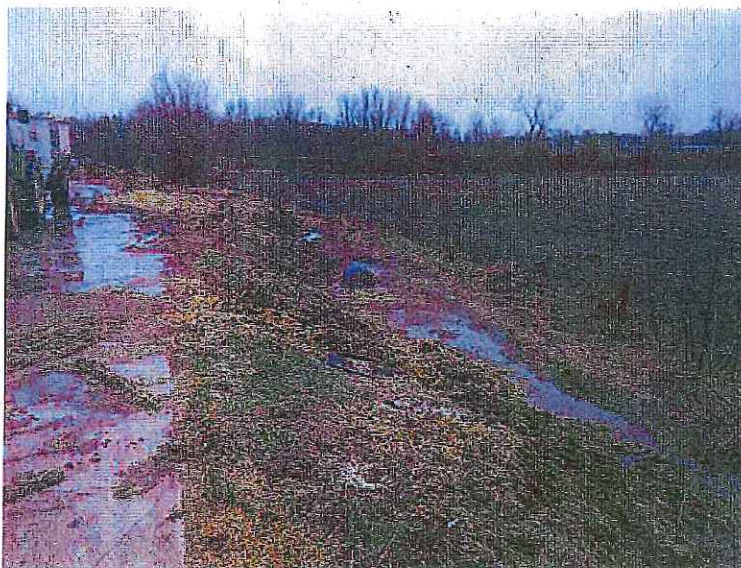
IMGP0024: West Ditch has flow in it under the silage that has been pushed off the silage pad.

IMGP0025: West Ditch has flow in it under the silage that has been pushed off the silage pad.

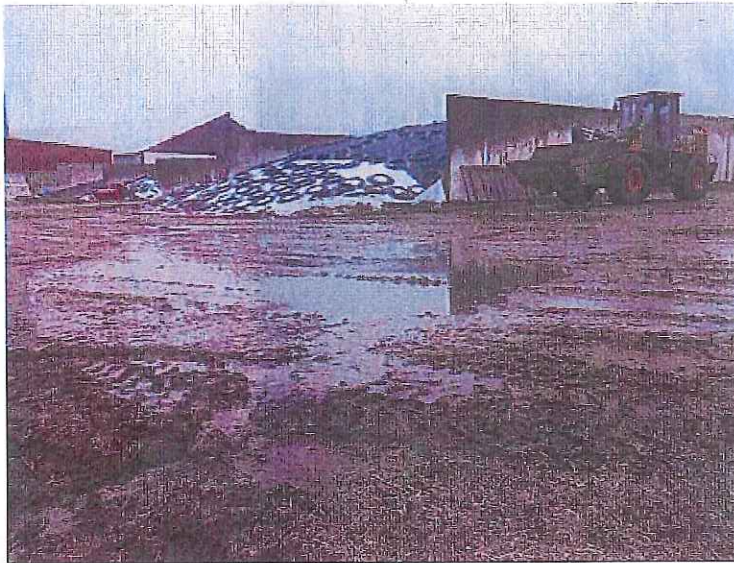
IMGP0027: Flow of surface water from the silage pad to the West Ditch. Note that there is water in the channel leading off from the silage pad.

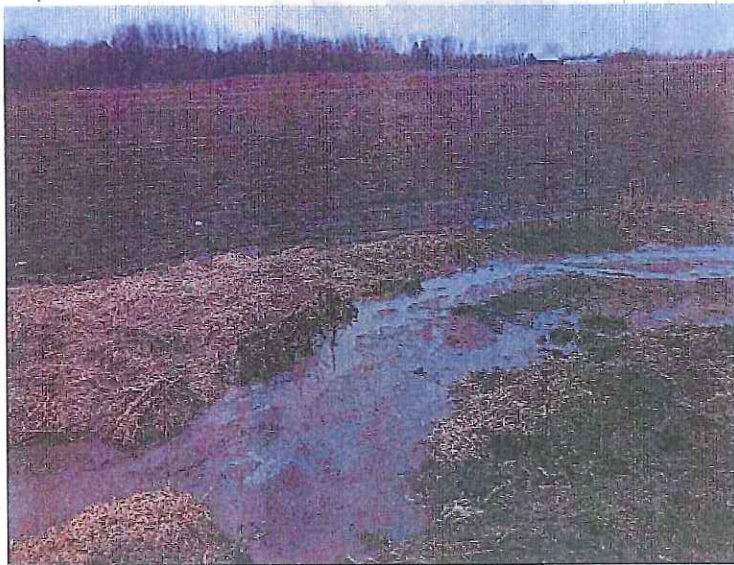
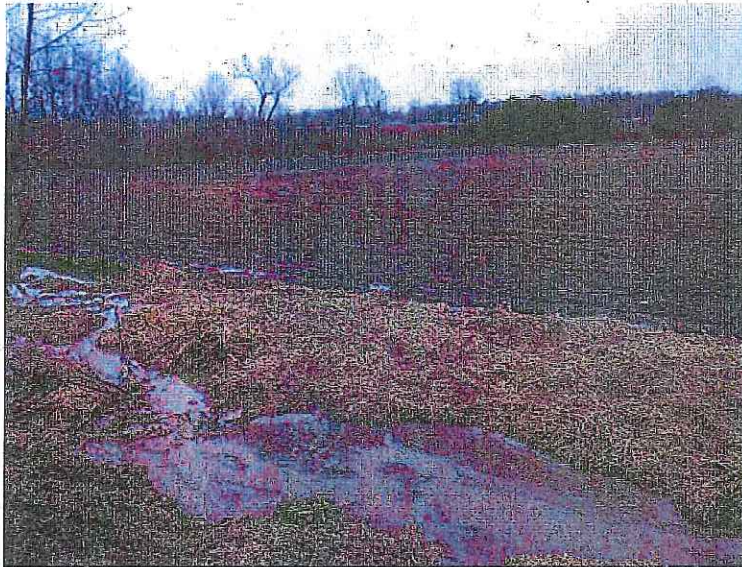
IMGP0031: Flow of water in the West Ditch and through the silage that is pushed off silage pad.

IMGP0032: Flow of water in the West Ditch and through the silage that is pushed off silage pad.

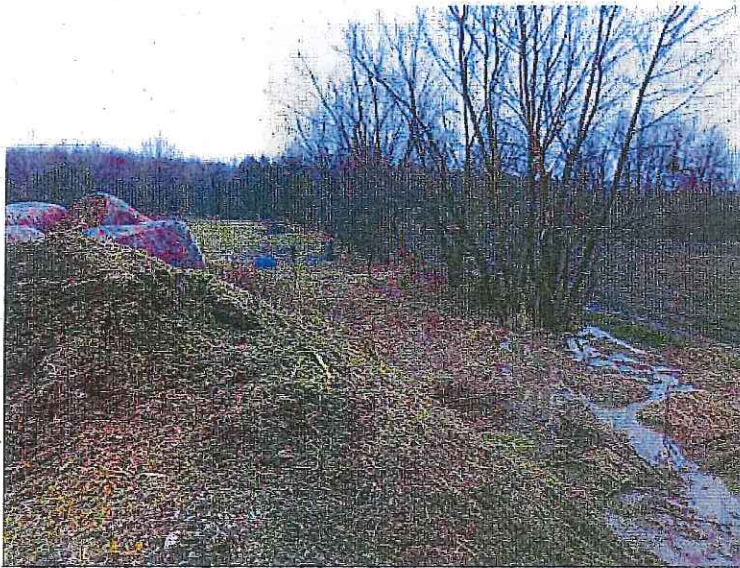
IMGP0033: Another pile of snow and silage from the silage pad is piled on the southwest corner of the silage pad.

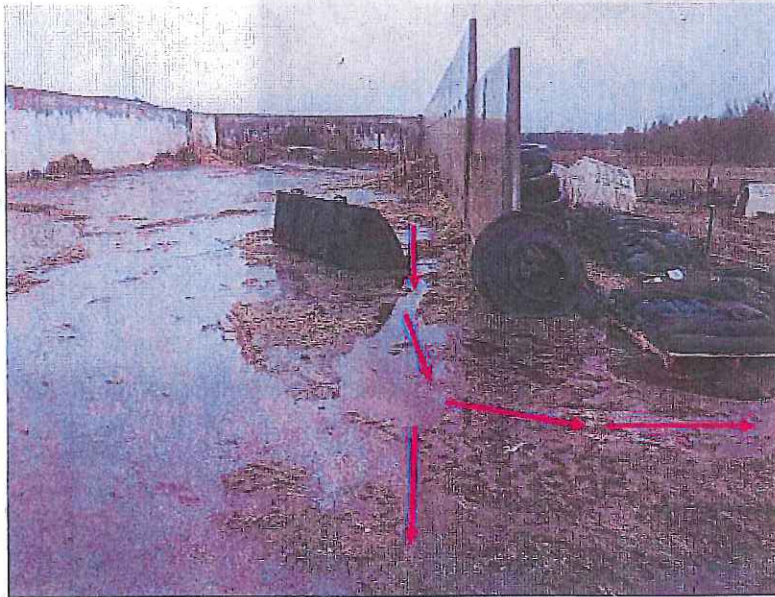
The southernmost feed storage bunker was being used to store manure solids. A flow of process wastewater from the manure stack flowed out of the bunker and some turned to the south where it went down the driveway to a pasture south of the feed storage bunkers, Pasture #1. Process wastewater from the manure stack also flowed directly to the west to the West Ditch.

IMGP0040: Manure is stacked in the southernmost Silage Bunker. Process wastewater pathway from the manure is identified by red arrows.

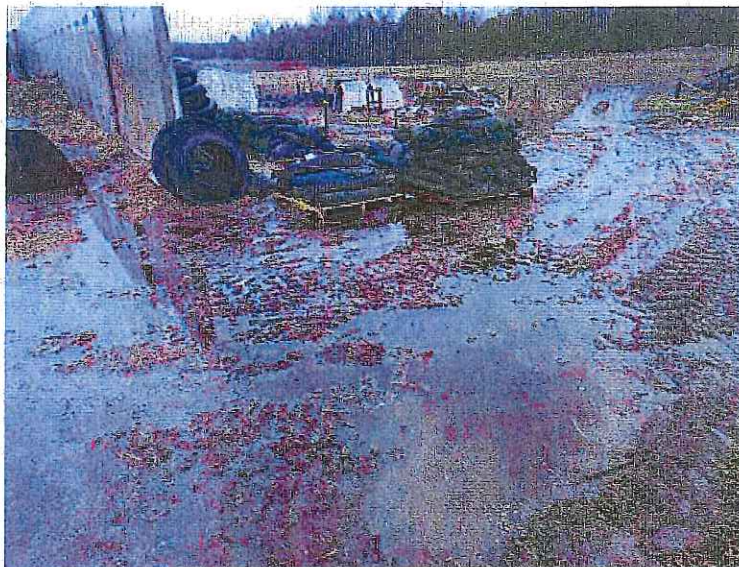
IMGP0041: Process wastewater from the manure flows out of the bunker and down the driveway to Pasture #1 and to the West Ditch.

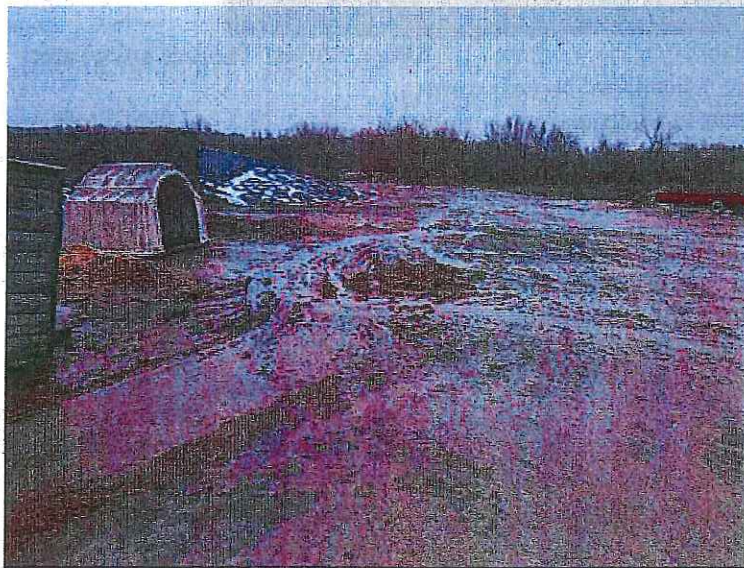
IMGP0042: Silage pad is tilted to the west. There is no curbing to prevent process wastewater from reaching the West Ditch.

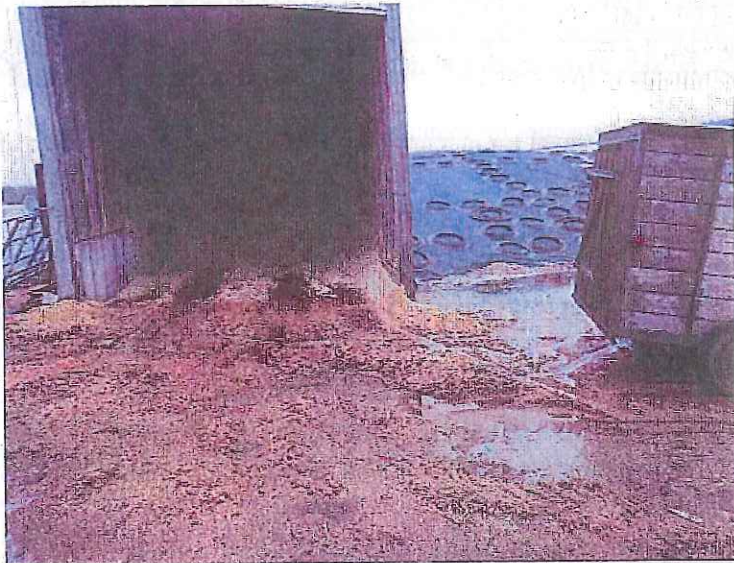
IMGP0043: Sawdust stored in bunker has a significant amount of track in/track out.  
 Location: North end of silage pad  
 Facing: East  
 Date/Time: 4/18/13 10:31 A.M.

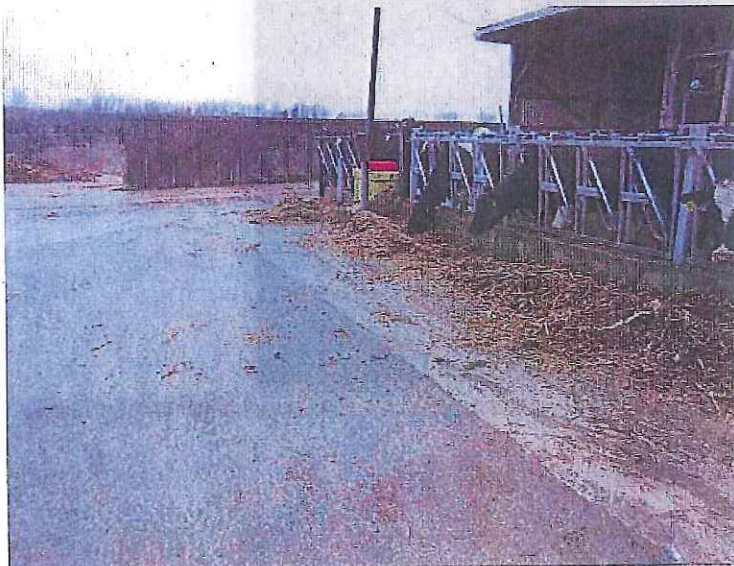
IMGP0045: Feed for dry cows can be transported by precipitation to the West Ditch.  
 Location: South side of Dry Cow Barn  
 Facing: West  
 Date/Time: 4/18/13 10:32 A.M.

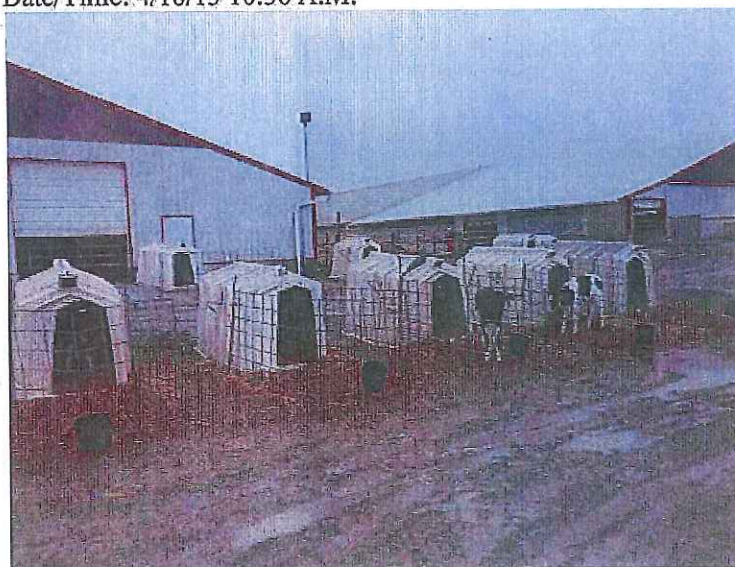
IMGP0056: Calf hutches on south side of Barn #2. No containment for runoff from the calf hutches and runoff is able to flow to Pasture #2.

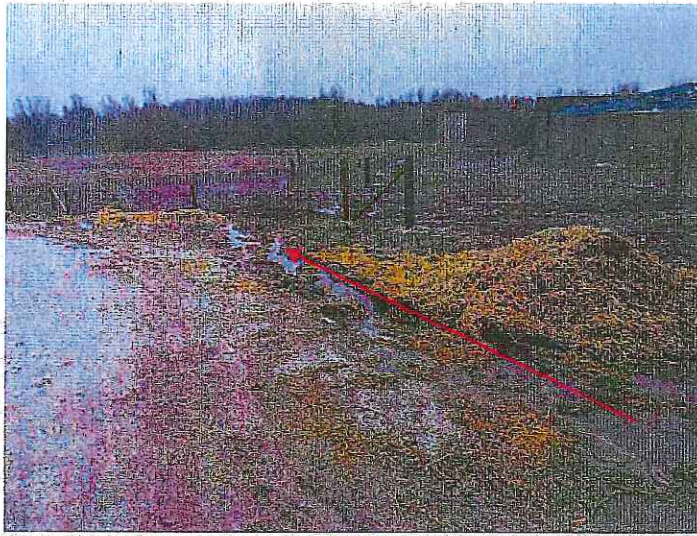
EPA observed channelization of the precipitation from the south side of Barn #2 to the north side of Pasture #2. The precipitation flowed through piles of used bedding from the calf hutches before flowing to Pasture #2.

IMGP0057: Channelization of flow from the south side of the Dry Cow Barn and the south side of Barn #2. Flow goes through a pile of used bedding from the calf hutches. Red row denotes location and direction of flow.

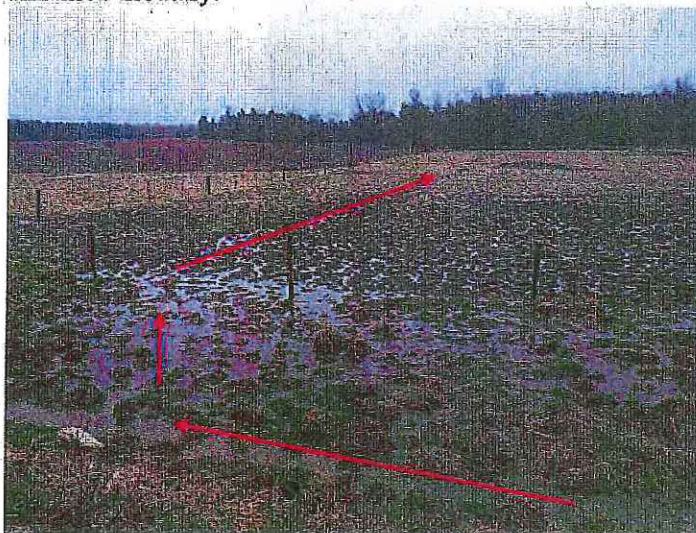
IMGP0062: Flow pathway through Pasture #2 flows to the south. Red arrows denote general flow pathway location and direction.

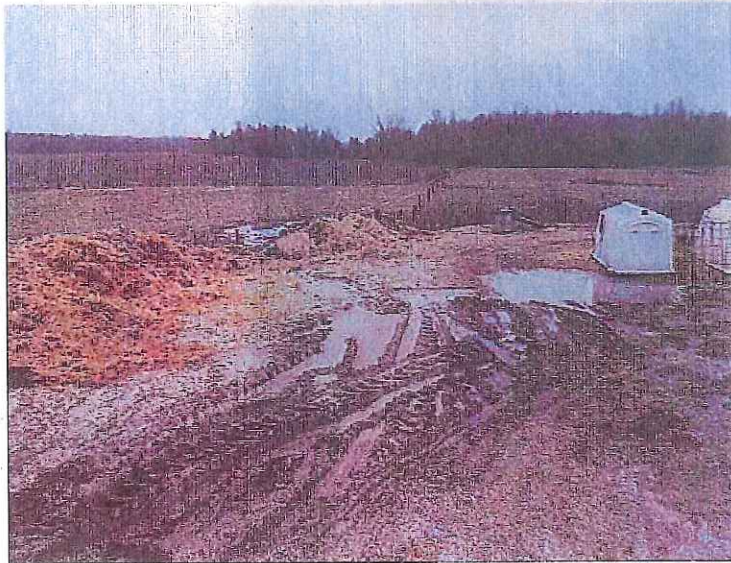
Additional piles of used bedding from the calf hutches were piled on the southeast corner of the production area, south of the Main Barn. Manure and process wastewater flowed off these piles and into the northwest corner of Pasture #3.

IMGP0064: Bedding from calf hutches on top of snow pile pushed to southeast corner of calf hutch area. Fence line delineates Pasture #3 on left from Pasture #2 on right.

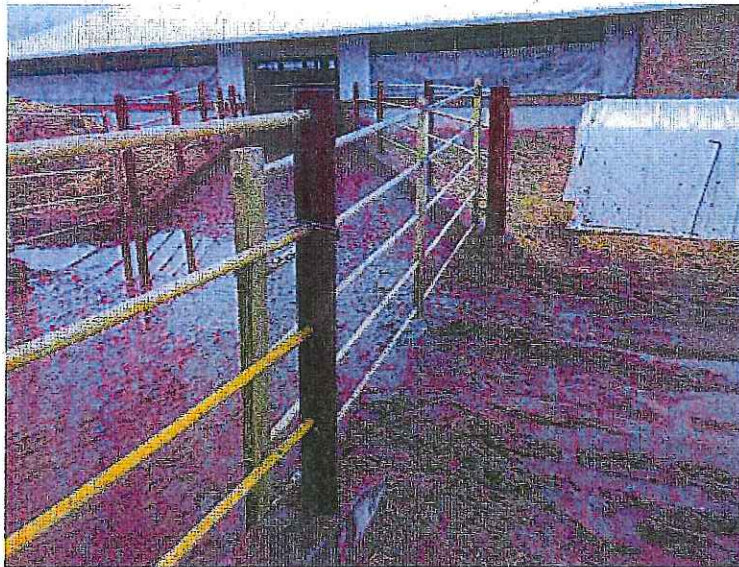
EPA also noted that the cattle walkway from Barn #2 to the Main Barn did not have complete containment for the manure and process wastewater. Manure and process wastewater from the walkway could flow with precipitation to the south.

IMGP0065: Cattle walkway from Barn #2 does not have complete containment for manure and process wastewater.

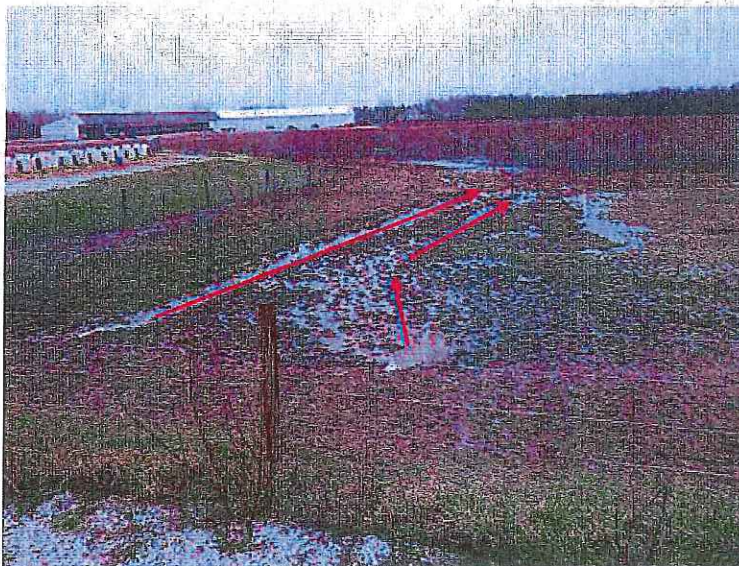
IMGP0069: White pipes discharge storm water to Pasture #3 which channels and flows to the east side of the Pasture #3. Red arrows denote location and direction of flow from the white pipes.

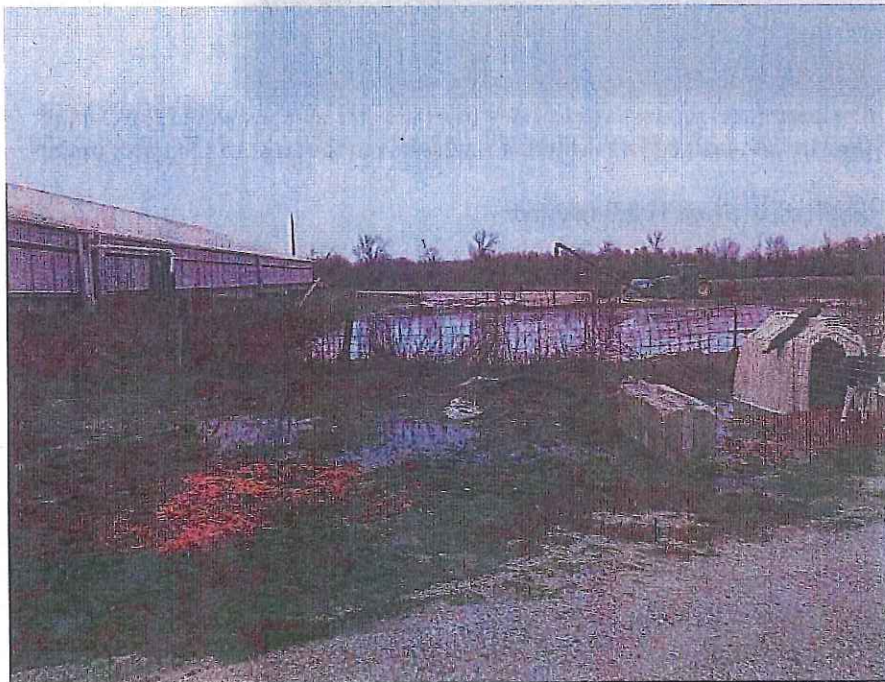
The holding pond on the west, the 1<sup>st</sup> Stage Holding Pond, was a concrete lined square manure pond. It was very full and had less than six inches of freeboard. EPA observed additional calf hutches on the south side of the pond. There was no containment for the manure and process wastewater from the calf hutches. Manure and process wastewater from the calf hutches would flow to the south and to the north end of Pasture #3.

IMGP0072: 1<sup>st</sup> Stage Manure Holding Pond is just to the east of the Main Barn. The holding pond is full. Manure channel from Main Barn is under the white pipe on the east side of the barn.

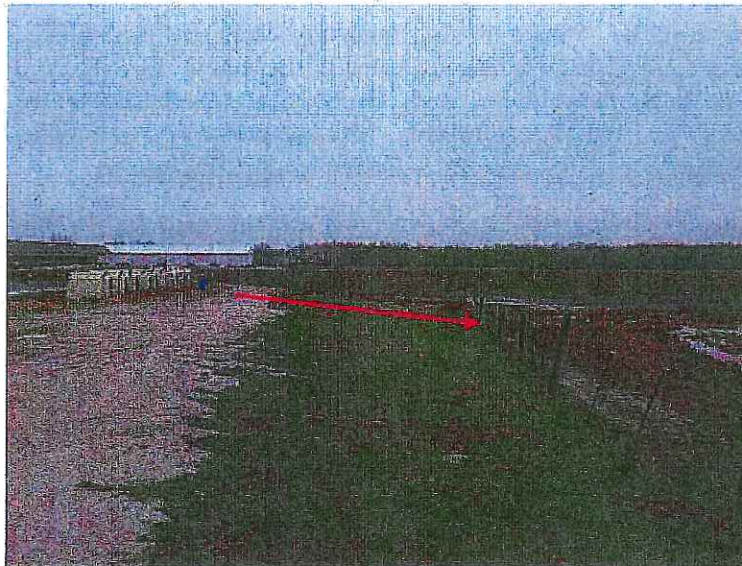
IMGP0074: Manure and process wastewater from the calf hutches would flow to the south and then to the north end of Pasture #3, which is to the right of the fence in the photo.

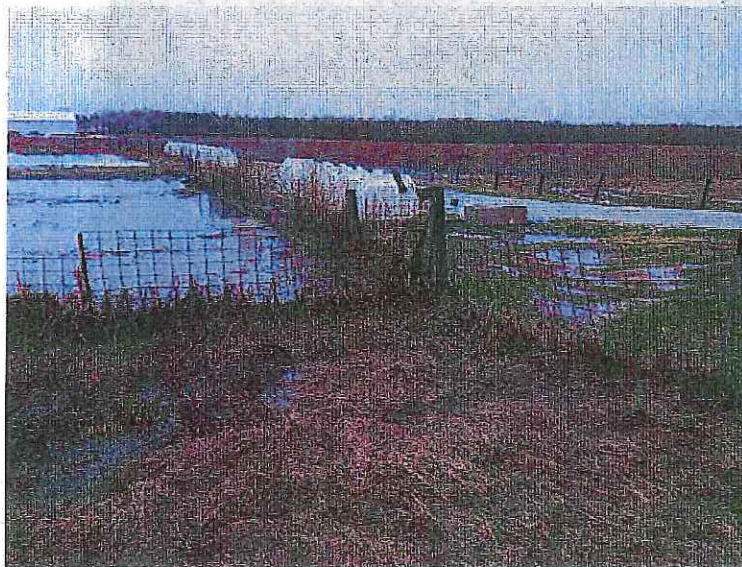
IMGP0075: Southeast corner of 1<sup>st</sup> Stage Holding Pond. Holding pond is full and appears to have overtopped the wall.

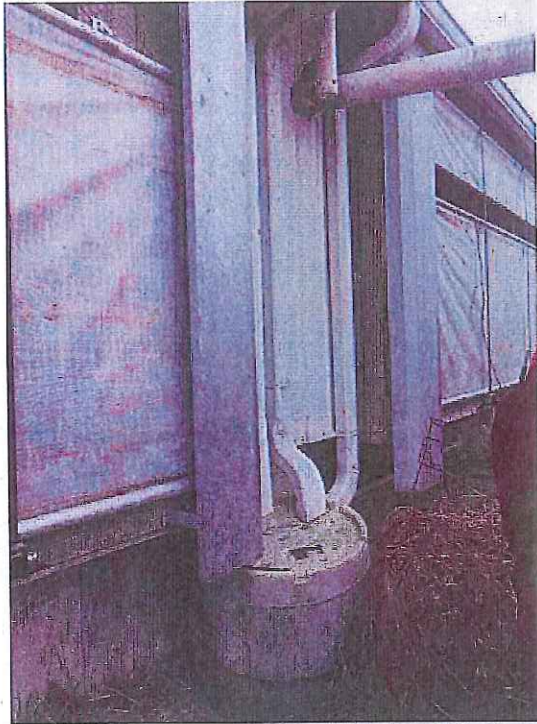
EPA observed that the eave gutters on the Main Barn were tied into downspouts. **Exemption 6** stated that the storm water discharged through one of the white pipes that EPA previously saw in the north side of Pasture #3 (photo IMGP0069).

IMGP0076: Eave gutters are piped and discharge through a white pipe in the hillside on northwest corner of Pasture #3 (IMGP0069).

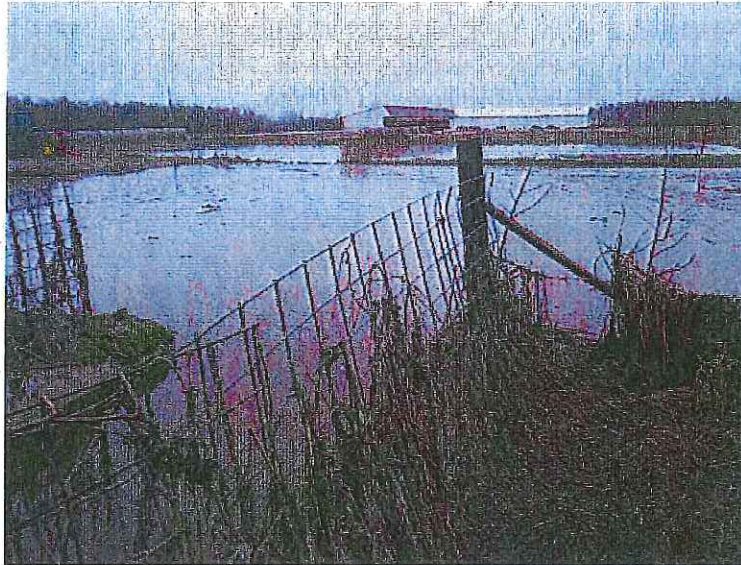
IMGP0077: 1<sup>st</sup> Stage Manure Holding Pond is full and backing up into the channel for the Main Barn. Manure solids on vegetation between the pond and the barn appear to indicate that the pond had overflowed.

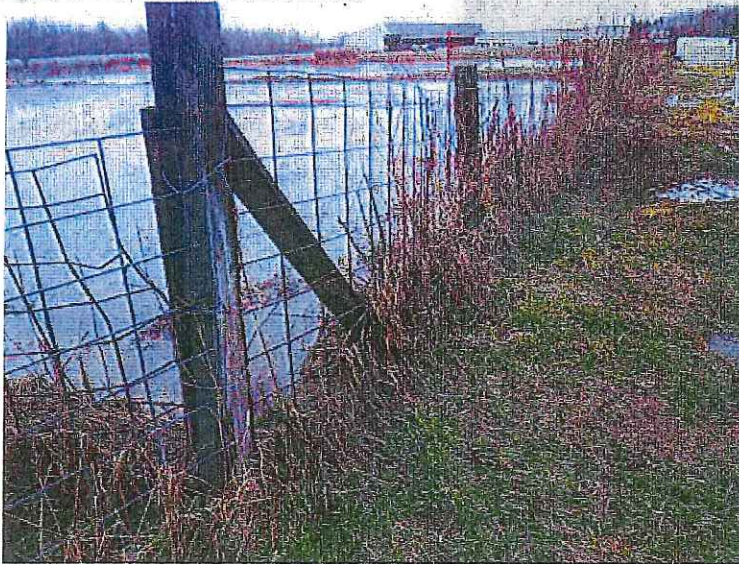
IMGP0080: It appears that the 1<sup>st</sup> Stage Manure Holding Pond overflowed onto the ground. Note the berm between the two ponds is barely above the manure level.

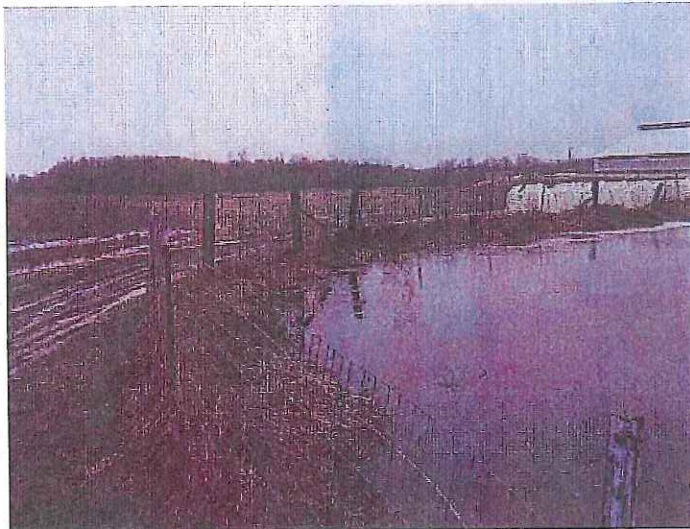
IMGP0085: 2<sup>nd</sup> Stage Manure Holding Pond is full. Five tanker trucks were lined up to remove manure from this pond when EPA arrived at the facility.

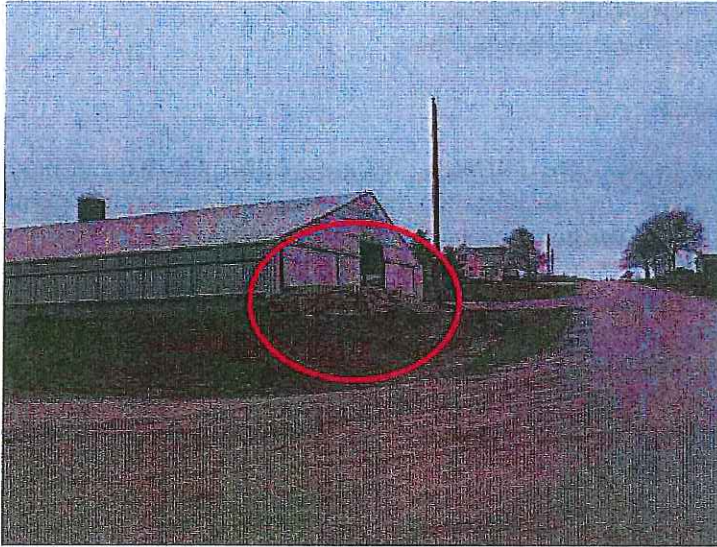
At the northeast corner of the Main Barn, EPA observed piles of manure and used bedding at both the northeast and northwest corners of the Main Barn that had been manually scraped out of the barn and since there was no barrier to prevent it, had also fallen into the roadside ditch. The manure and used bedding would be carried with the flow in the roadside ditch to the east and to the East Ditch where it eventually flowed into the perennial unnamed tributary.

IMGP0099: Main Barn has manure and used bedding piled in front of the barn (location indicated by red circle). Manure and used bedding is also in the roadside ditch in front of the Main Barn.

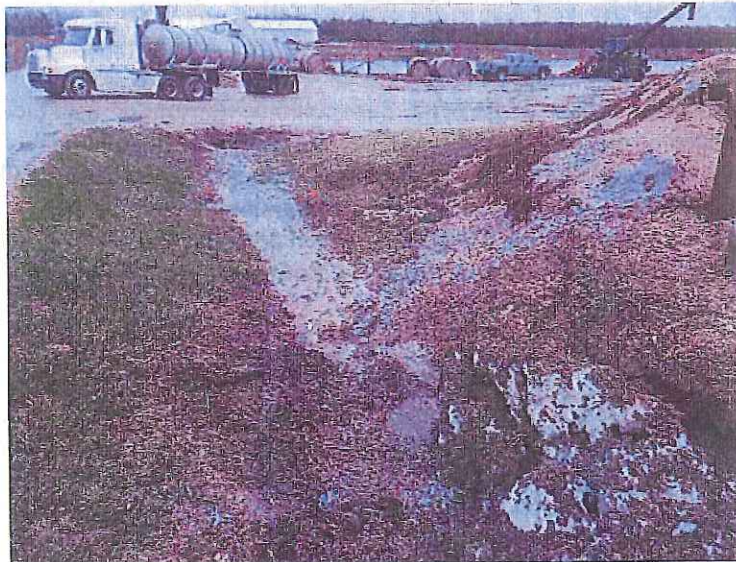
IMGP0102: Manure and used bedding, including the alternate bedding is piled in front of the northeast corner of the Main Barn. It is also in the roadside ditch.

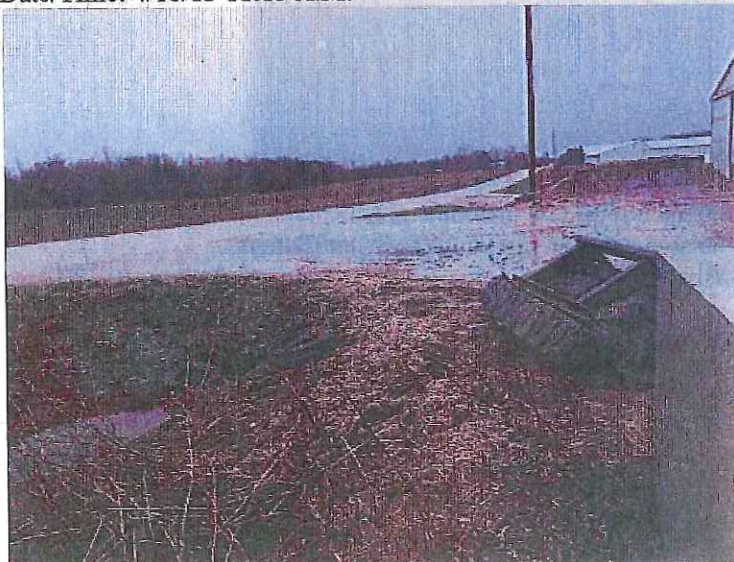
IMGP0106: Manure and used bedding in the roadside ditch north of the Main Barn from the northwest corner of the barn.

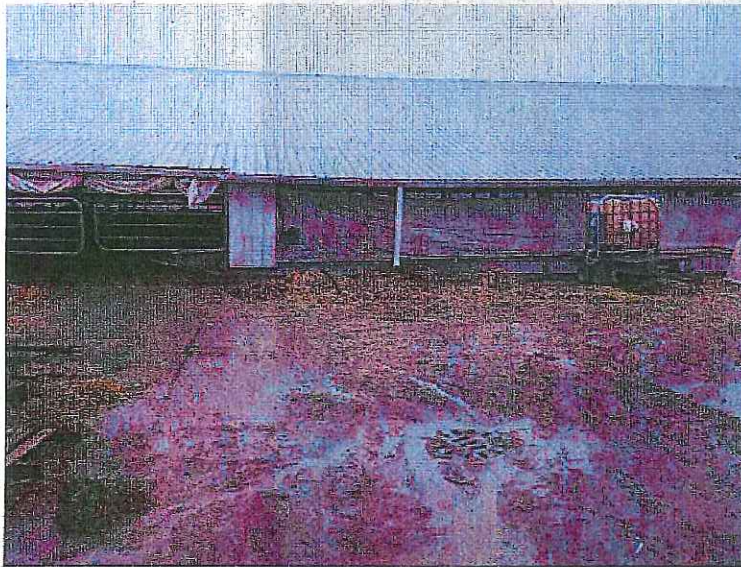
IMGP0110: Track in and track out of raw materials outside the Main Barn can flow to the inlet at the north end of the area between the Main Barn and Barn #2.

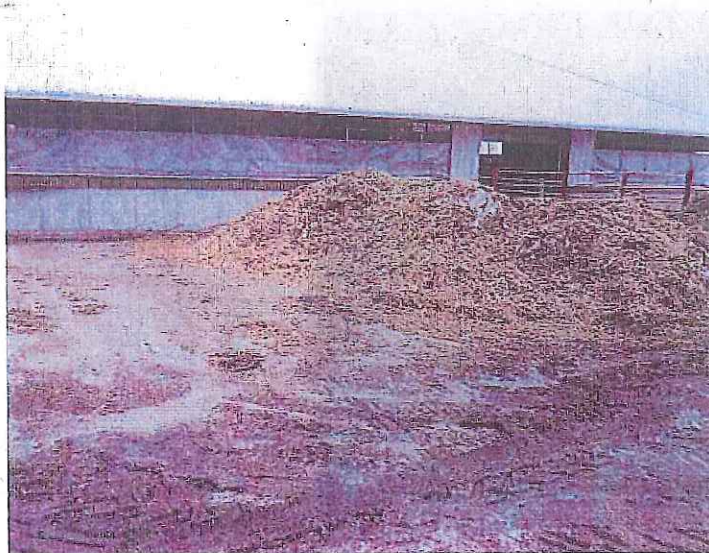
**IMGP0116:** Piles of used bedding scraped up with the snow are piled in the yard between the Main Barn and Barn #2. Process wastewater from the bedding can flow to this inlet on the south side of the area between the barns. The flow from the pipe outlets into Pasture #3 from a white pipe as shown previously in photo IMGP0069.

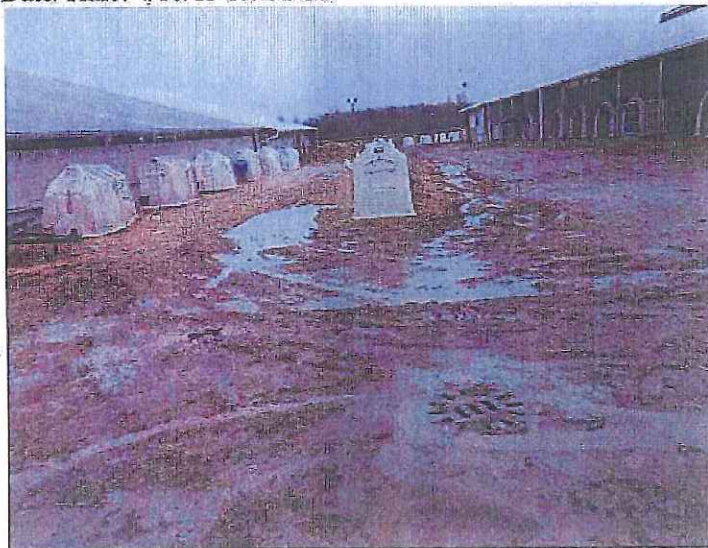
**IMGP0109:** Manure and process wastewater from the calf hutches can flow to the inlet and then to Pasture #3 via a pipe.

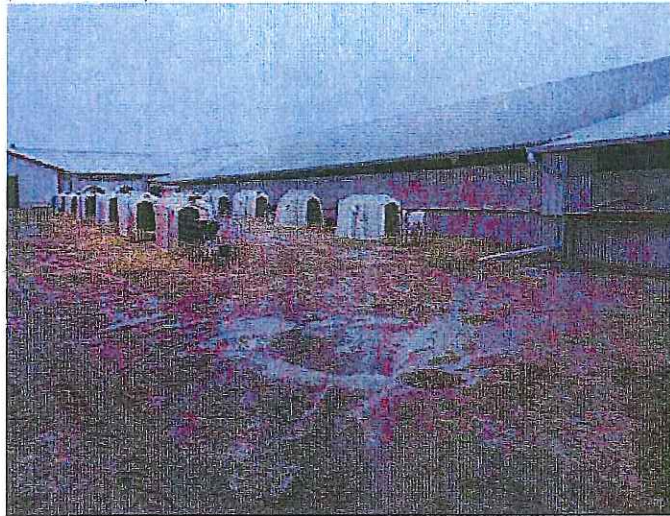
IMGP0117: Manure and process wastewater from the calf hutches also can flow to the south to the second storm water inlet.

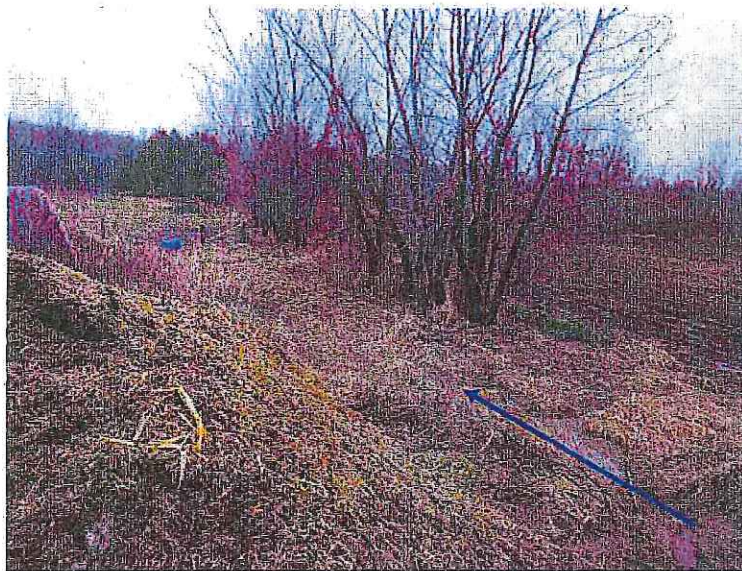
IMGP0125: Flow from manure in feed bunker flows to the West Ditch (indicated by blue arrow). Waste silage is piled up with snow along the West Ditch. West Ditch flows into Pasture #1.

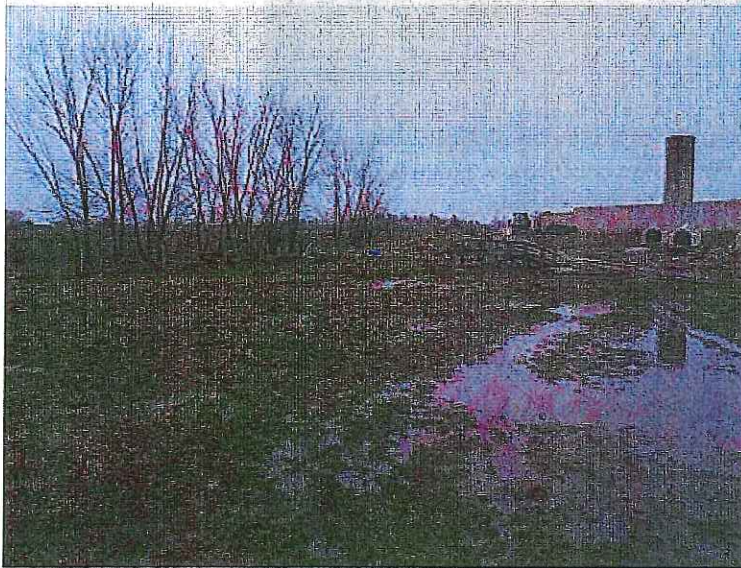
IMGP0141: Flow that goes south from the piles of silage flows into Pasture #1.

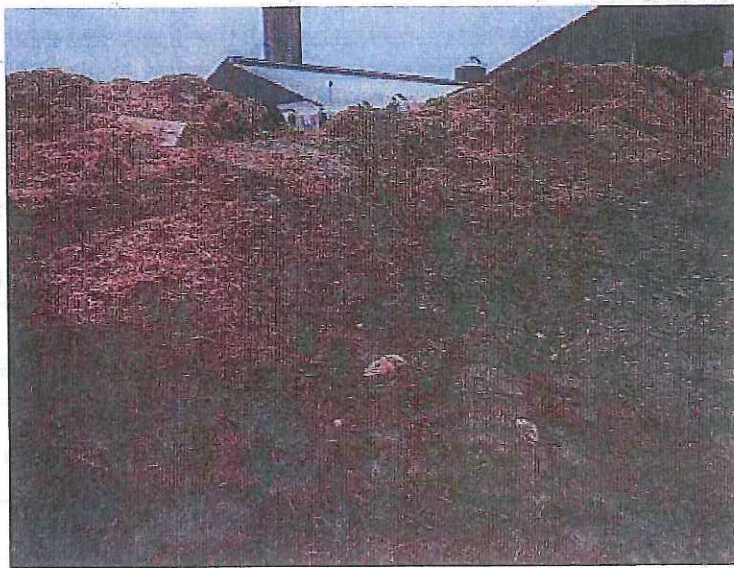
IMGP0175: Pile of snow with used bedding allows process wastewater to flow down the hillside into the northwest corner of Pasture #3.
